PROPERTY INSPECTION REPORT

Concerning: **1234 Anywhere Ln. The Woodlands, Tx 77301**

By: **Rodney Sims / Lic # 10271, Teresa Sims / Lic # 20230**

09/16/2011 / 10:00am

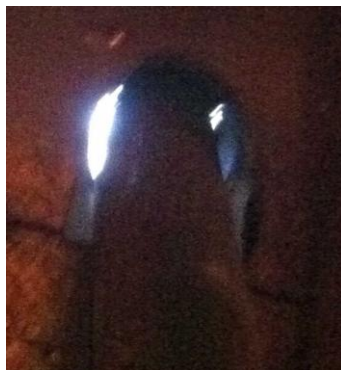
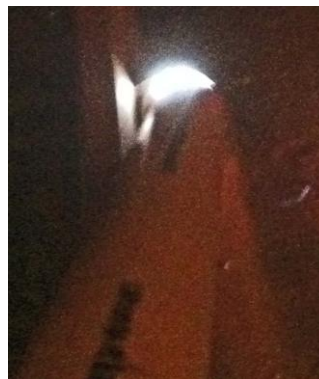
-The Gas Exhaust Vent 'Roof Jack' has an exposed opening because it does not have a rain collar on it above the roof. (This situation is causing rain water to enter the structure, which has apparently been flowing onto the water heater and then collecting in the overflow pan. The overflow pan is 'very' rusted'.)

-A Rubber Boot at a Roof Jack has an exposed opening due to damage and is not sealing properly. (This situation is may be causing rain water to enter the structure.)

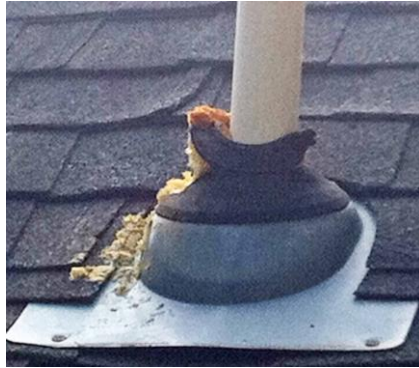
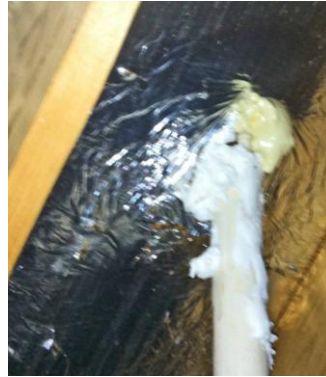
- A Rubber Boot at a Roof Jack has is substantially damaged and has been filled with spray foam. The roof decking also appears to be damaged at this location.**
(This situation has apparently caused damage and deterioration to a substantial amount of roof decking in the adjacent area.)

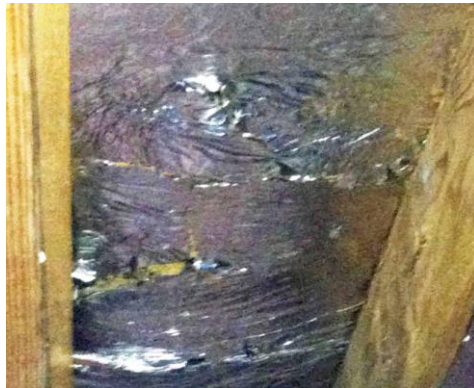
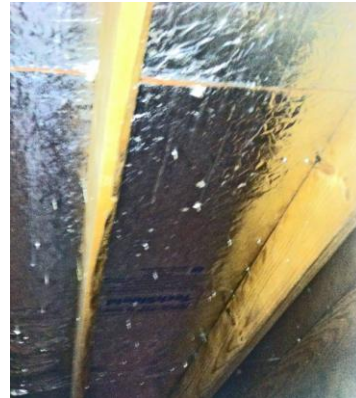
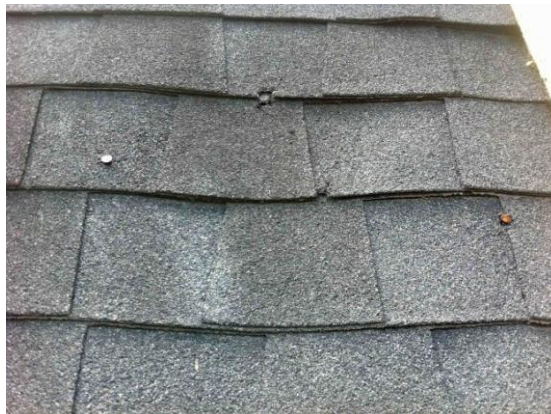
- A large area of roof decking over the master bath has substantial deterioration and damage due to an apparent leak in the PVC roof jack above the area. (See the above related item.)**

NOTE: Damaged or deteriorated roof decking is commonly 'mostly hidden' from view when TechShield is present.

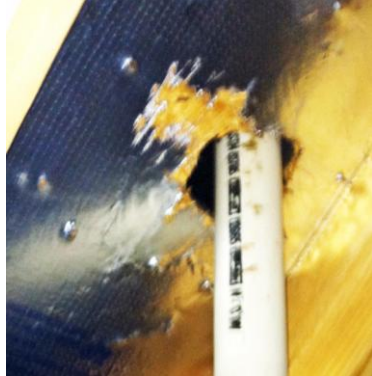
-A Rubber Boot at a Roof Jack has is damaged and is allowing water intrusion over bedroom-2.

NOTE: In the attic, there is a blue tarp under the area and there is a water stain on the ceiling under the area in bedroom-2.

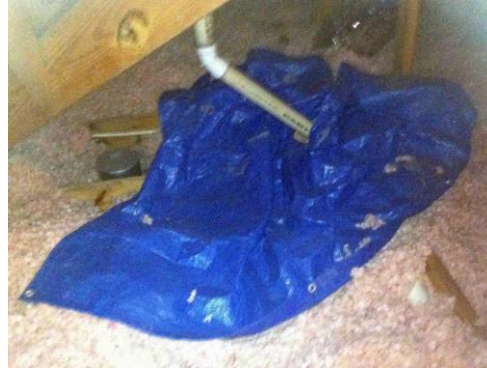
(Another damaged Rubber Boot at a Roof Jack)

****IMPORTANT OVERALL NOTE:** The inspector observed damage, deficiencies, or incorrect installation of 'almost every' roof jack on the house. Based on this observation, the inspector recommends proper replacement of 'every' PVC and Gas Exhaust roof jack on the structure.

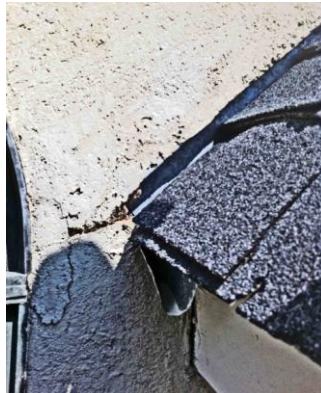
-A required 'Kickout Flashing' is not present in the front, to the upper left of the breezeway. (With stucco siding, properly instated Kickout flashings are IMPERATIVE to prevent possible water intrusion into the structure)

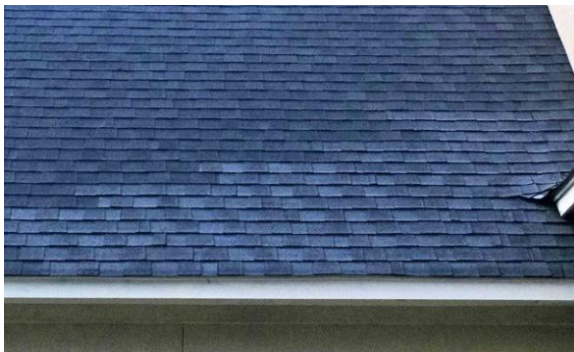
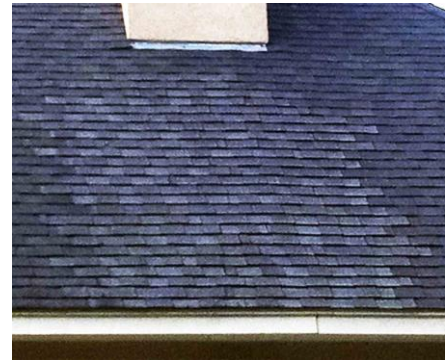
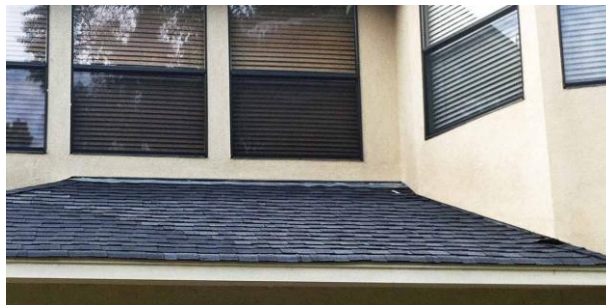
NOTE: In the back, there has been apparent repair/replacement of the shingles in at least three or four locations.

NOTE: It is the inspector's understanding that the owner stated that they were due to a possible condition with the shingles (referred to in terms the inspector does not recall).

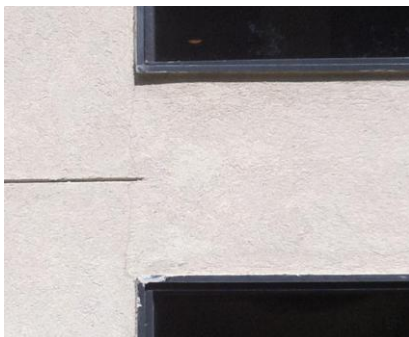
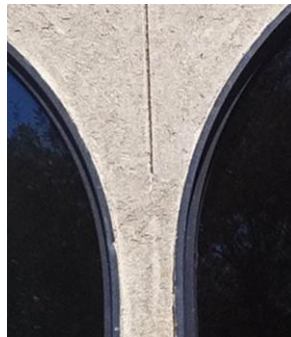
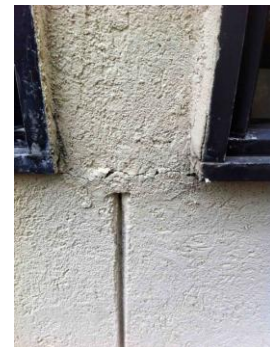
NOTE: It 'appears' that there may have been previous repairs to the stucco.

This is most apparent in the back at the large section of windows. In this area, it 'appears' that the Control Joints have been 'removed' or that mortar was placed 'over' the joints for some reason. .

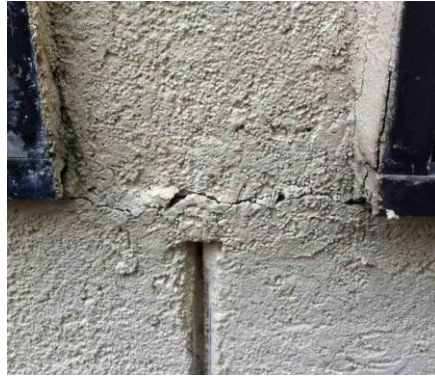
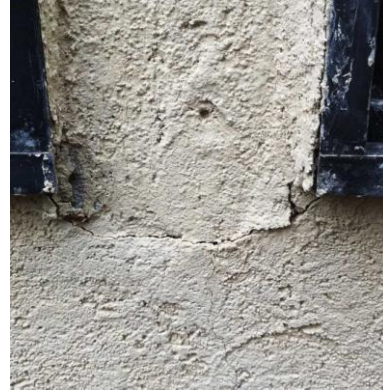
NOTE: Also, in some areas, there are significant differences in the surface texture of the mortar

(‘Apparent’ Variance in Texture)

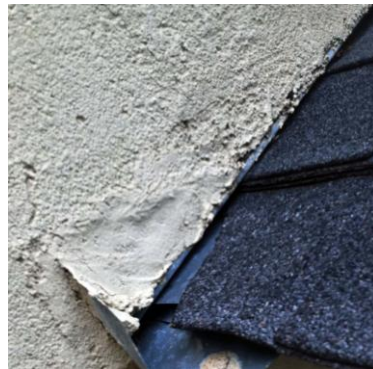
(‘Apparent’ Kickout Flashing Adeed)

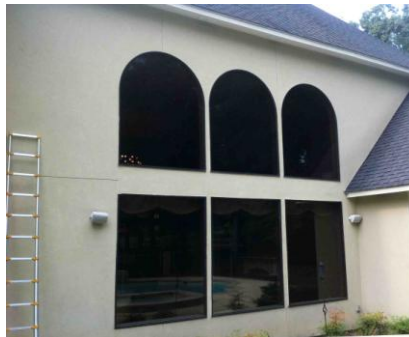
-In some areas, there are no Control Joints present as there should be. (‘Some’ areas without control joints are at the following locations:

-At the right of the front door

-In the back, at the large windows at certain areas

NOTE: Without control joints in the appropriate locations, slight ‘controlled’ movement is not possible and cracks in the stucco can occur.

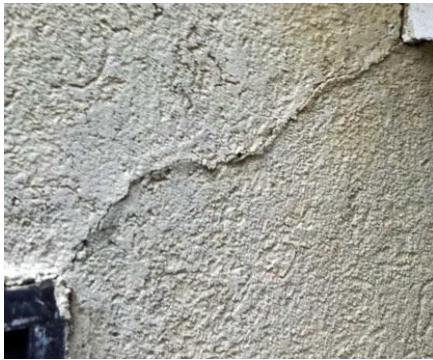
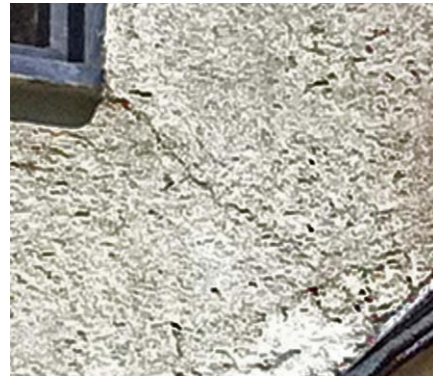
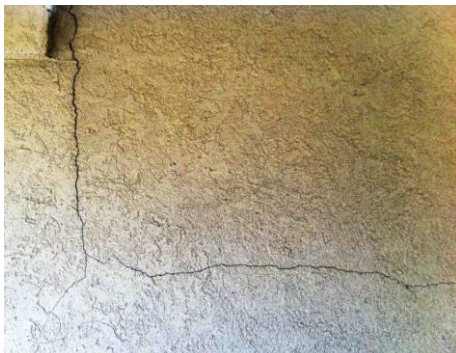
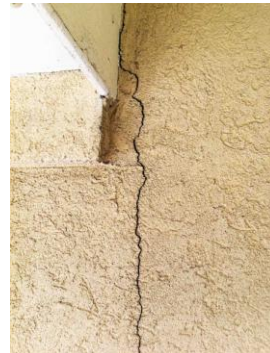
-There are 'many' cracks in the Stucco in numerous locations.

NOTE: Some of the cracks may be 'surface coat' only, but 'a few' may be deeper.

('Some' of the cracks are pictured below)

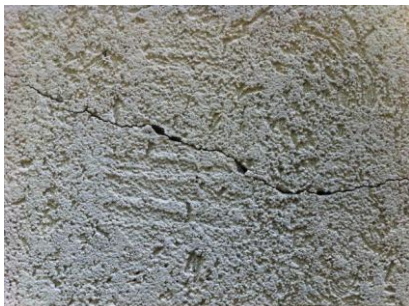
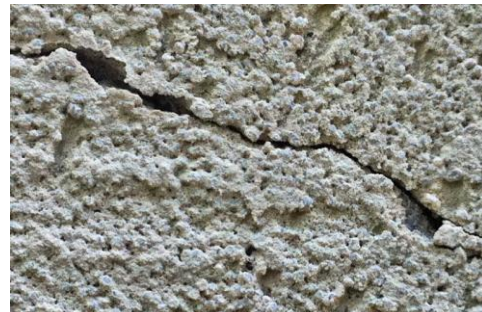
(Close up of photo to the left)

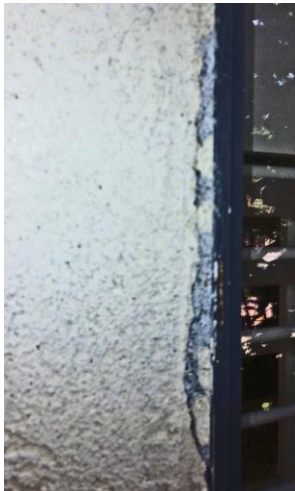
Side of Window

*****NOTE:** At the base of some windows, the Stucco 'projects outward further' than the window. This condition can 'bead and collect' water, allowing it to penetrate behind the stucco. **(SEE ABOVE PHOTO)**

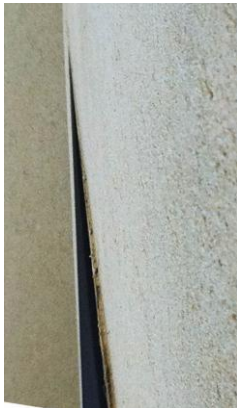
- NOTE:**
- A great number of the windows project outward 'at differing amounts', while other windows are completely flush with the stucco.
 - 'Some' of the windows are installed flush in one area, but slant outward significantly at another area.
 - This issue may complicate a method to remediate an effective solution to the window joint solution. (SEE below photos for examples)

(Window flush at top and protruding at the Base)

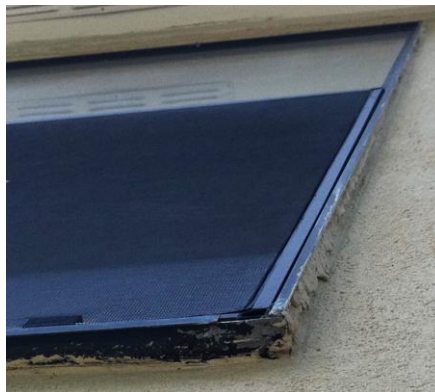
(Window protruding almost 1-Inch at the Base)

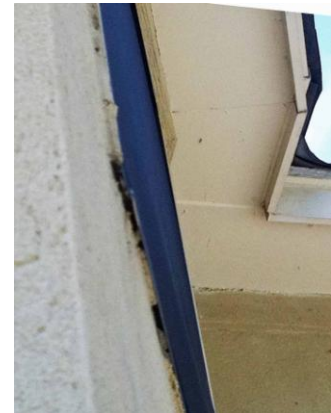
(Window protruding excessively)

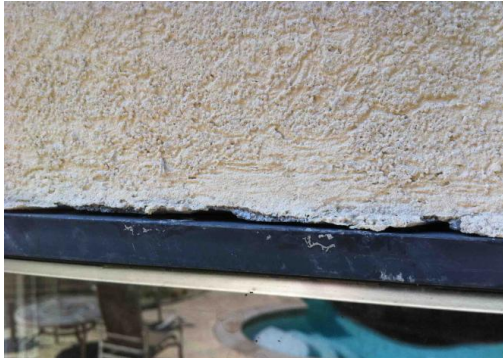
- At almost all of the windows, there is 'no' Head Cap Flashing at the windows.

IRC CODE REFERENCE: R703.8 (Exterior) Flashing.

1. At top of all exterior window and door openings in such a manner as to be leakproof.

(Current Top of Window)

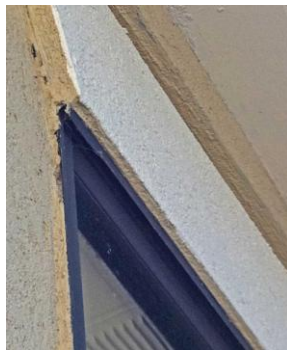
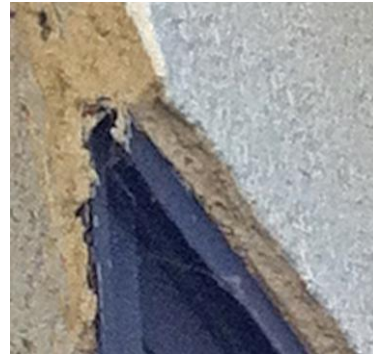
NOTE: The windows at the front of the garage are a different type, and have a 'pre-installed' Head Cap Flashing at the top. (If a 'pre-installed' Head Cap Flashing is NOT present on a window, one MUST be installed.)

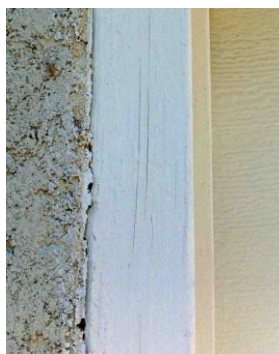
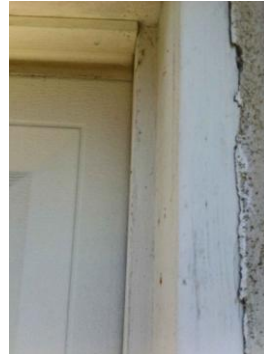
-At numerous locations, the Stucco to Wood intersections were not installed properly. Some of the stucco has cracked away from the wood. (This issue is very similar to the stucco to window intersections, and can allow water penetration into the atructure.)

NOTE: The cracking of the stucco may have been caused by expansion and contraction at different temperatures, OR vibration and movement of the wood, such as at door jambs. This is why proper installation of Casing Bead Joints around windows, doors, etc... is so critical.

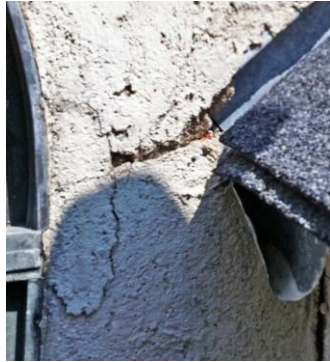
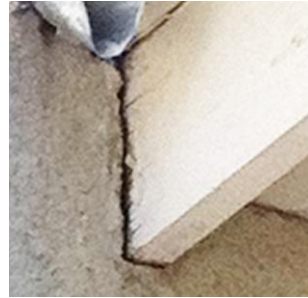
-There is a major installation defect or damage to the Stucco in the front, to the upper left of the breezeway.

-At the same location, the Fascia Board is embedded in the stucco, which can cause water penetration into the structure.

NOTE: The inspector highly recommends that this is repaired at the same time as the Kickout flashing is installed at the same location.

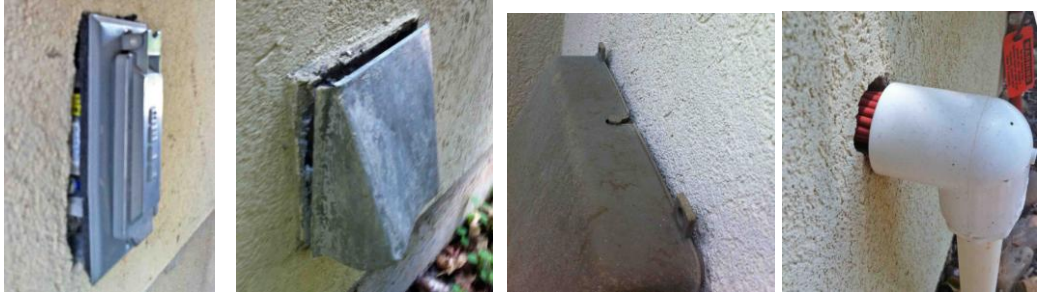
- In the front, a Water Heater Drain Line is almost half way buried in the stucco.
- Numerous exterior receptacles are not 'secured' and 'sealed' properly.
- The Dryer Vent is not secured and 'sealed' to the house.
- Numerous additional exterior wall penetrations are not Flashed and Sealed, as required.

(Some examples are pictured below)

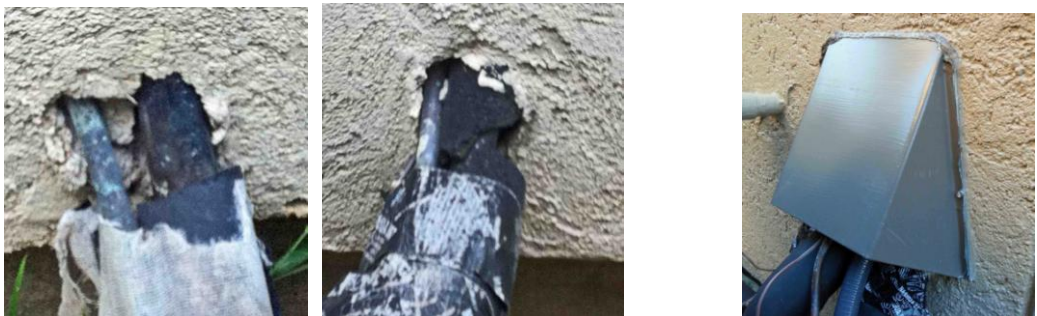
- The Outside A/C Quick Disconnect Boxes and additional electric boxes should be sealed should be 'sealed' at the top and sides, to prevent water penetration.

NOTE: An outdoor receptacle the inspector examined under the window had an unusually rusted mounting nail in it. This 'may' be an indication of prior excess moisture in the wall.

- The A/C Refrigerant Lines are not 'Flashed', as required, to prevent water penetration into the structure. (It may be helpful to add a supplemental 'Refrigerant Line Cover' such as the one pictured at the lower right.)

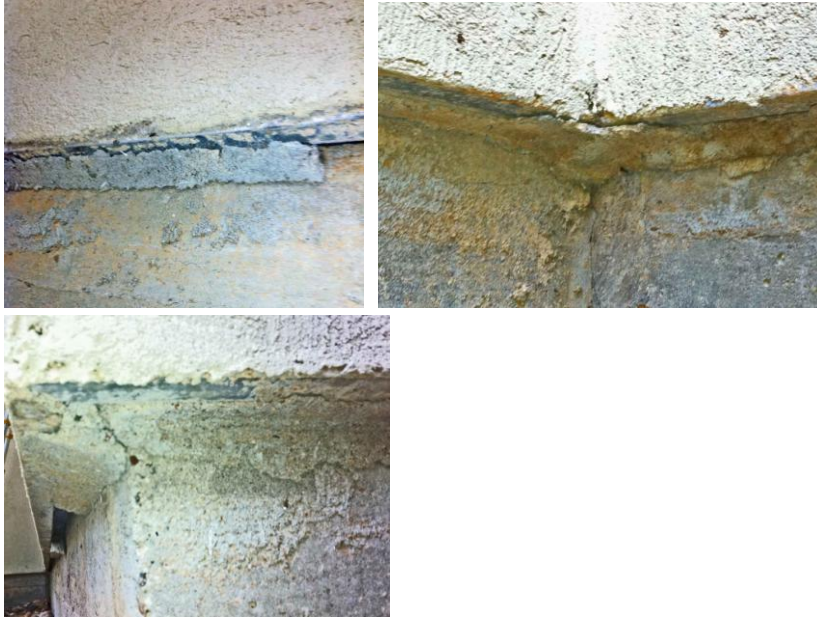
-At the base of the stucco, the Casing Bead has been 'incorrectly' filled in with mortar. (This is incorrect and detrimental because the back of the casing bead facilitates drainage of any moisture or condensation from behind the stucco.)h'

NOTE: In many some areas, the mortar had already become dislodged and fallen off.

-Due to the issues noted, the inspector Highly Recommends that the method of Stucco installation be reviewed and inspected by a Highly Competent Stucco Specialist.

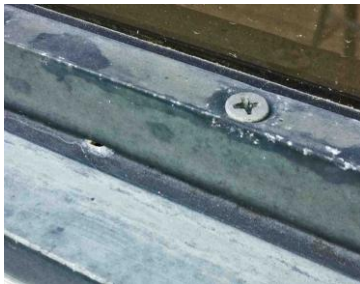
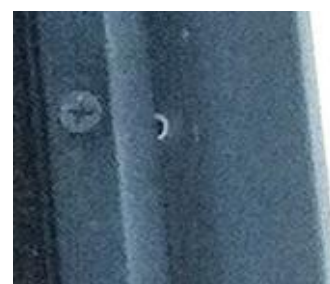
-Some of the windows have exposed 'screw holes' on the exterior. (This may be an indication of replacement or incorrect installation.)

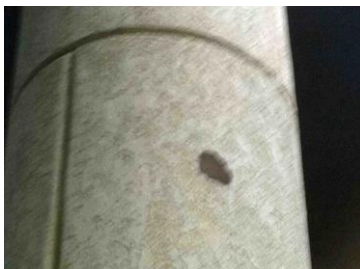
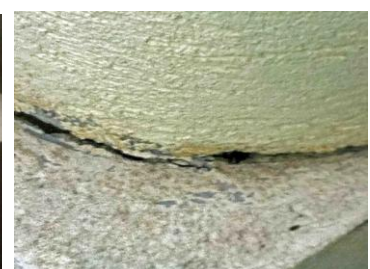
- There are 'holes' in 2 of the columns in the front. (The columns are made of EIFS.)
- There is slight damage at the base of one of the columns.

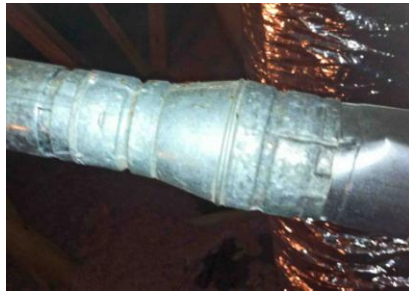
-The gas line to the furnace did not have the required 'drip leg' (sediment trap).
(This prevents any sediment from entering the furnace burners)

-The furnace power cord for the blower motor does not have the required 'grommet protection' where it enters the furnace. (This is an Electrical Hazard.)

-The Exhaust Vent has been downsized from a 4-inch vent to a 3-inch vent, which is not allowed. (Also, the corresponding roof jack is a 3-inch jack designed for a Water Heater, not a furnace.)
