PROPERTY INSPECTION REPORT

Concerning: **1003 Anywhere Ln. The Woodlands, Tx 77380**

By: **Rodney Sims / Lic# 10271**

12/02/2009 / 1:00 PM

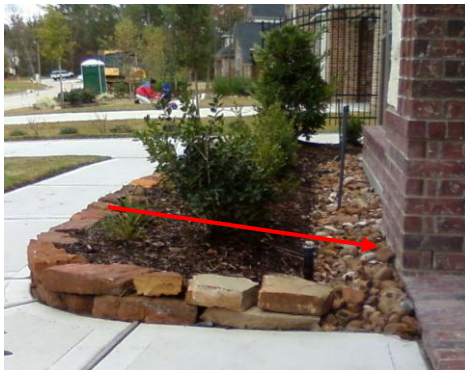
-In the front, to the left of the porch, 'negative grade' was observed with the landscaping sloping toward the house. There did not appear to be any secondary drainage system in that area. (The same was observed, to a lesser extent to the right of the porch)

-In the front, to the left of the porch, 'negative grade' was observed with the landscaping sloping toward the house. There did not appear to be any secondary drainage system in that area.

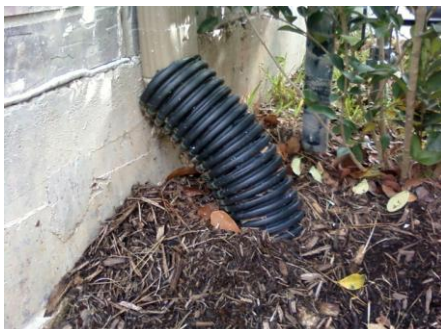
-The inspector was unable to determine the termination point for the downspout underground drain that is on the front right of the house.

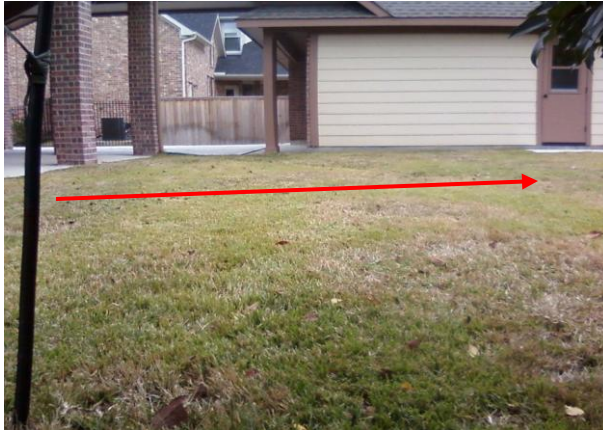
-In the back yard, extending out from the patio, the 'grade' did not have the required 'downward slope' away from the house. (Some slight signs of 'water ponding' were observed)

-In the back yard, extending out from the patio, the 'grade' did not have the required 'downward slope' away from the house.

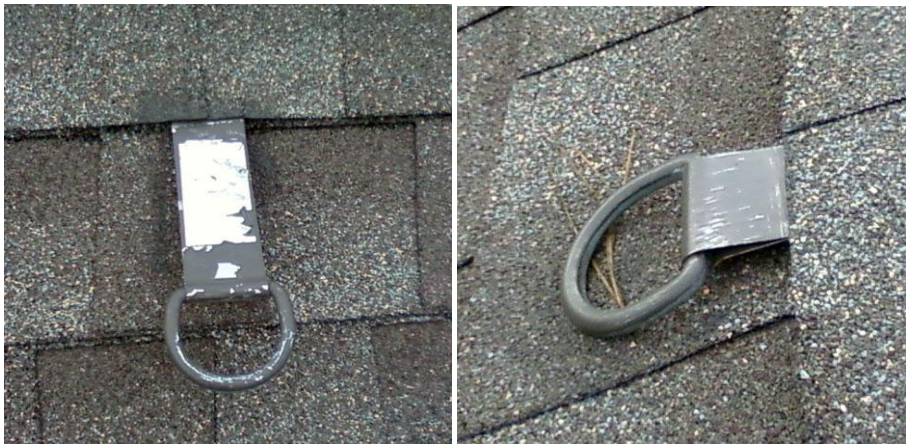
-At least two areas were noted where 'temporary metal tie straps' were still attached to the roof shingles.

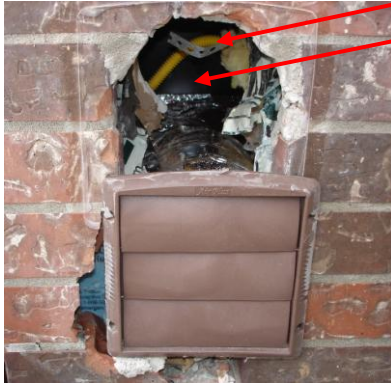
-On the left side, a significant portion was incomplete where the range vent exited through the wall. (NOTE: The inspector observed that the exposed opening through the wall penetrated from the 'exterior brick', through the 'outer sheathing', through the wall cavity, and through the sheetrock on the interior of the wall (exposing the flexible gas line and blower unit inside the house). The inspector 'suggests' the interior wall be sealed appropriately before the brick is reinstalled)

-On the left side, a significant portion was incomplete where the range vent exited through the wall.

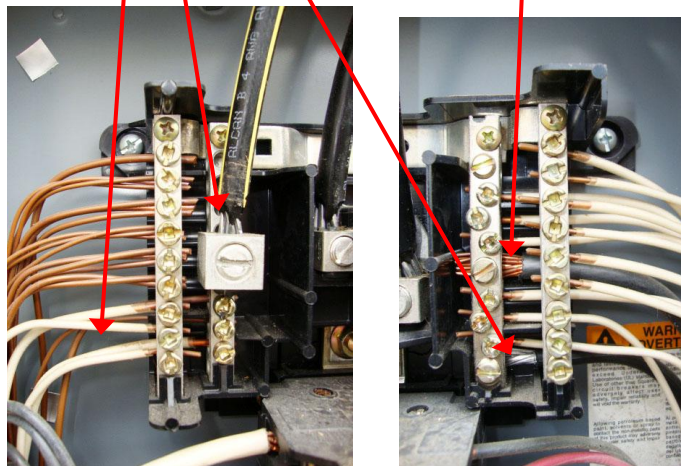
- There should be a 'trip-tie' joining the breakers for the dishwasher and garbage disposal.
- 'Some' of the white 'Neutral Wires' are incorrectly connected to the Ground Bar.
- The main 'Neutral Feed' is incorrectly connected to the 'ground bar'.
- There is NO 'Grounding Electrode Wire' or Bonding Cables' connected to the ground bar.
- On the right side, the 'Bonding Wires' and 'Grounding Electrode Wire' are incorrectly connected to the 'Neutral Bar'.

-'Some' of the white 'Neutral Wires' are incorrectly connected to the Ground Bar.

-The main 'Neutral Feed' is incorrectly connected to the 'ground bar'.

-There is NO 'Grounding Electrode Wire' or Bonding Cables' connected to the ground bar.

-On the right side, the 'Bonding Wires' and 'Grounding Electrode Wire' are incorrectly connected to the 'Neutral Bar'.

-Due to the issues observed, recommend service and system check by licensed Electrician.

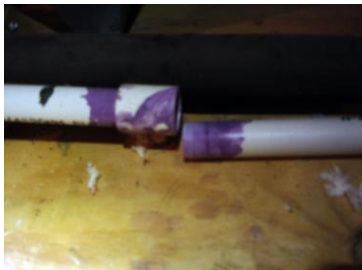
-'One' of the A/C condensate drain lines had become disconnected.

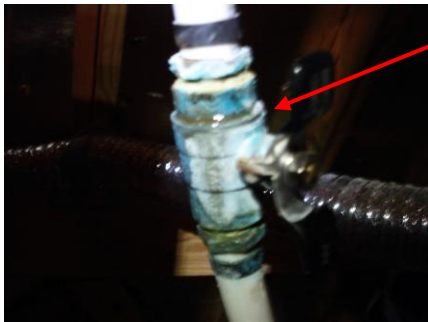
-The cold water shut-off valve assembly was 'corroded'. (blurred photo)

-The cold water shut-off valve assembly was 'corroded'.

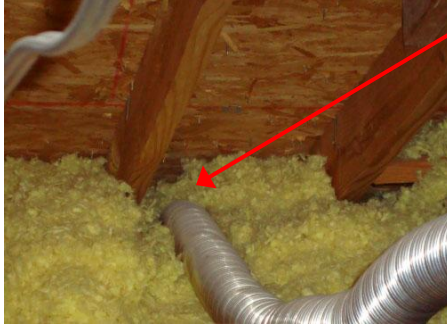
NOTE: One of the Bathroom Mechanical Exhaust Vents did not 'appear to' exit directly to the outside air as required. (Terminating into a 'soffit' is not allowed)

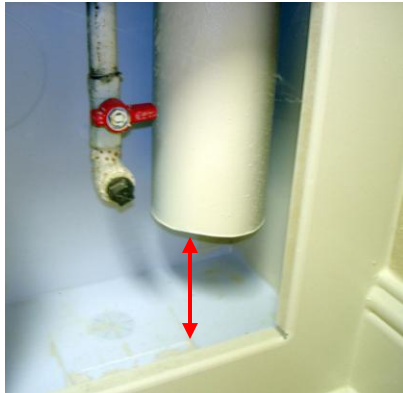
-The Dryer Vent exhaust pipe, in the inspectors 'opinion', is too close to the bottom of the opening, possibly making connection of the dryer flex line difficult.
