Real Estate Inspection Specialist

Roof Issues which can 'ONLY' be Located by an **Actual 'Physical' Roof 'Top' Inspection**

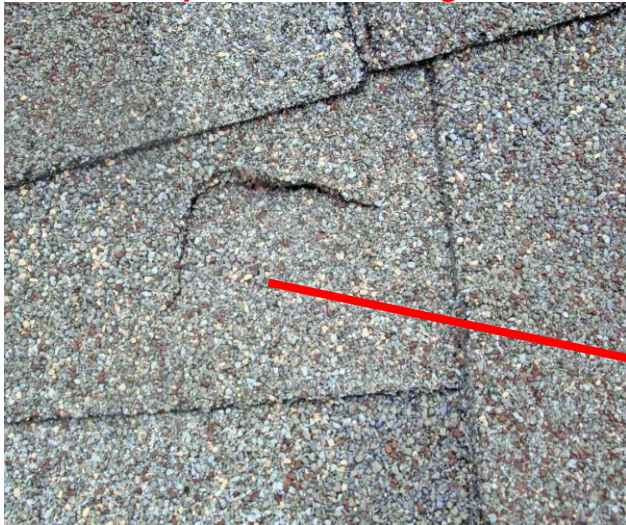
-Example-1 (Completely Broken Shingle located in a Critical Roof Valley)

Wide-view of Critical Roof Valley
where the Broken Shingle was located
(IMPOSSIBLE to see from a Ground Inspection)

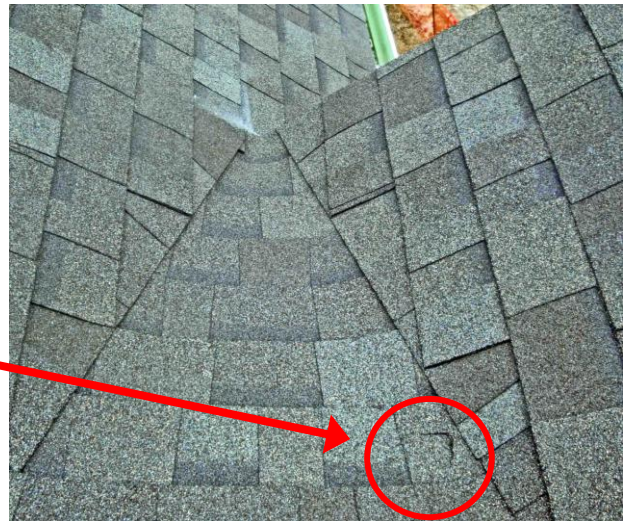
Close-up of Broken Shingle

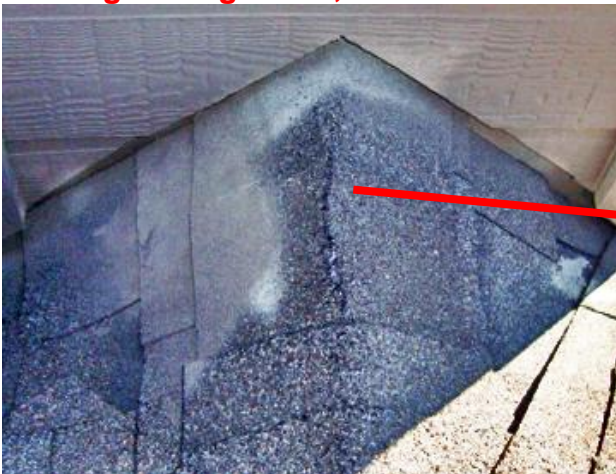
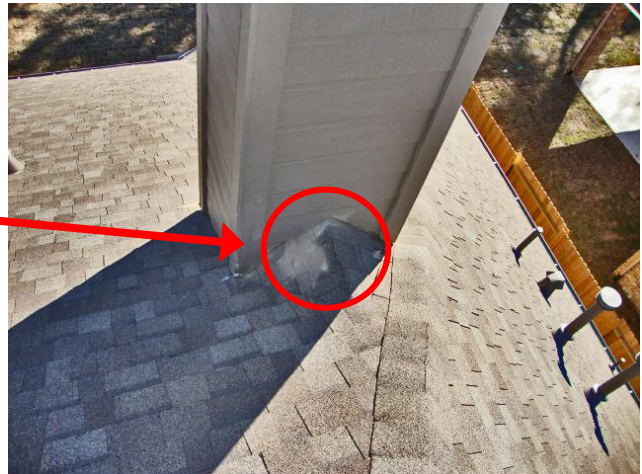
-Example-2 (Completely Exposed Roof Decking) (Exposed to the Weather and Rain) **The Decking WILL get Wet, Lead to Wood Rot**

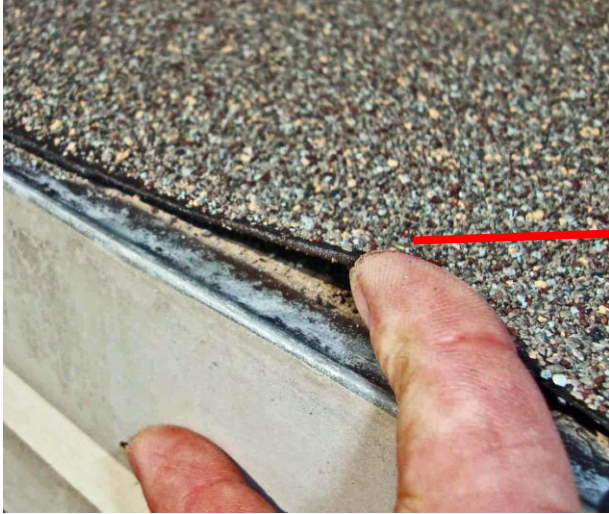
-Example-3 (Flat Roof 'Not-Sealed' Issue) (On Top of a 4-Story Townhome)

Close-up of 'unsealed' Flat Roof Material
The area WILL Leak to the Inside and
Eventually Leak to Ceiling Sheetrock

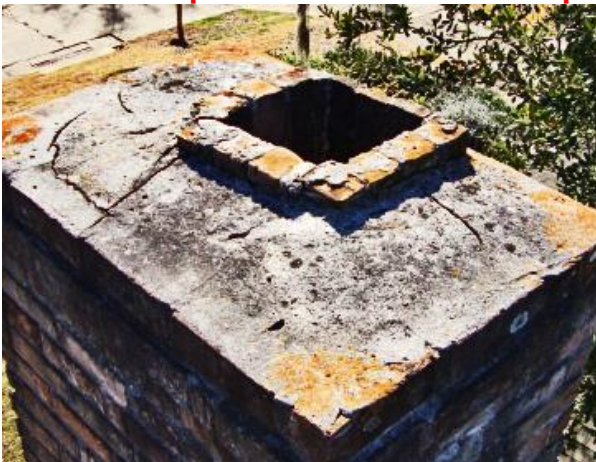
-Example-4 (Chimney with NO 'Rain Cap' and a cracked 'Mortar Cap')

**Close-up of Chimney with
NO Rain Cap and cracked Mortar Cap**

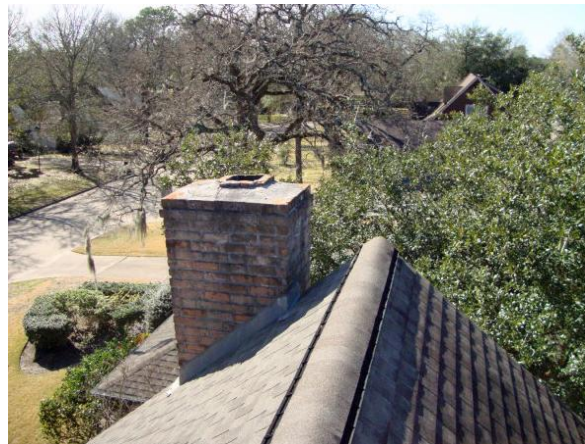
Wide-view of Chimney
(IMPOSSIBLE to see from a Ground Inspection)

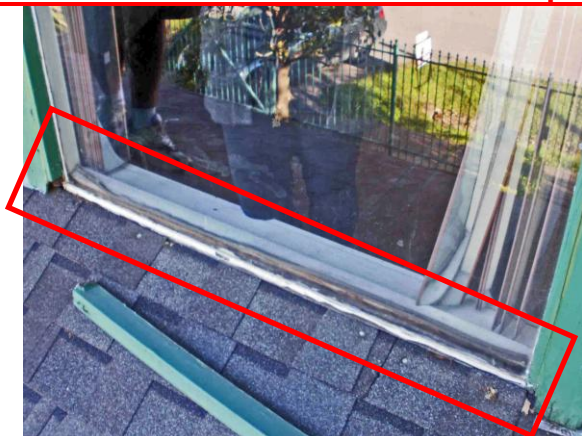
Absolutely NO Flashing at Window Base
Window Sill Totally Loose. WILL Leak
Under Shingles and ROT the Roof Decking
(IMPOSSIBLE to see from a Ground Inspection)

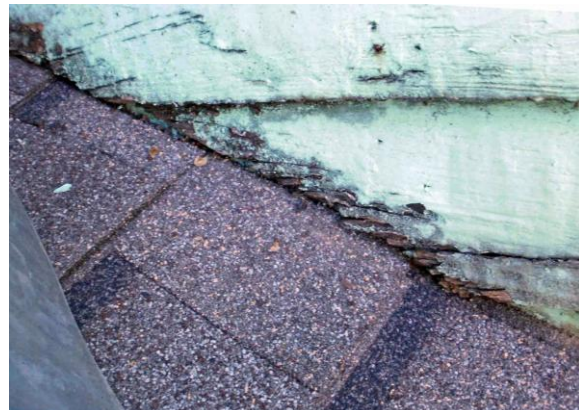
Absolutely NO Flashing at Wood Side Wall
The Wood Rot 'was' 'hidden' with a metal strip
Roof Decking below, WAS ALREADY ROTTING
(IMPOSSIBLE to see from a Ground Inspection)

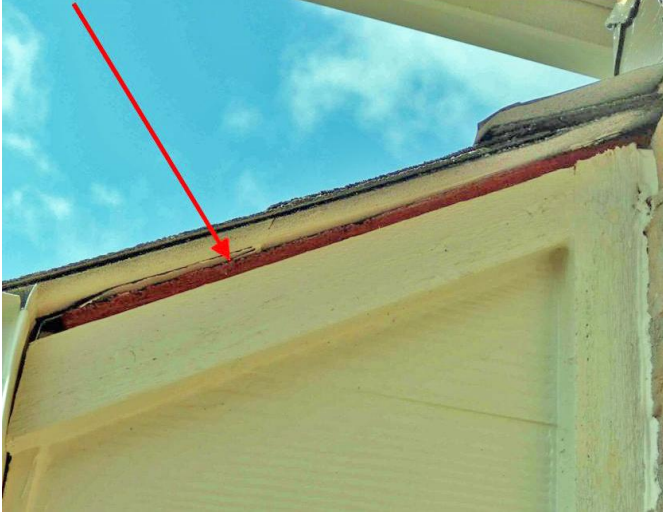
(Completely Exposed Roof Decking)

(Exposed to the Weather and Rain)

**This Decking WILL get Wet, Lead to Wood Rot
and Possibly LEAK into House**

(IMPOSSIBLE to see from the Ground)

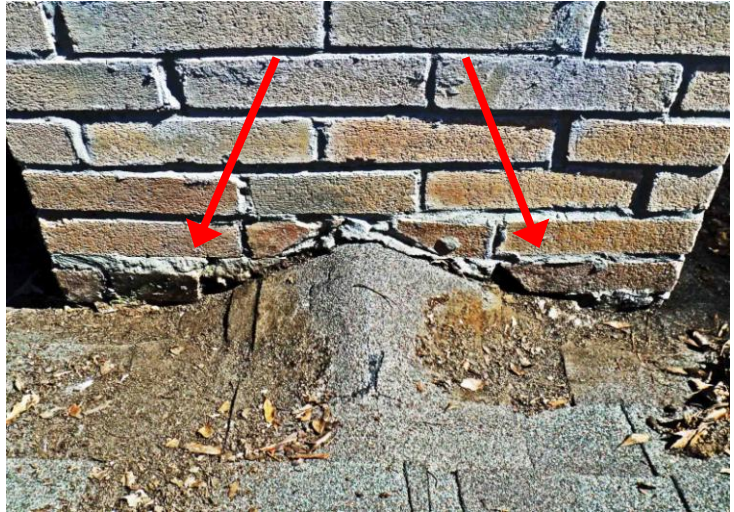
(Back of Brick Chimney)

(A Critical area Check due to Leaks)

**Absolutely 'NO' Metal Flashings
which are critical to prevent Roof Leaks
(IMPOSSIBLE to see from the Ground)**
