PROPERTY INSPECTION REPORT

Concerning: **1234 Anywhere Ln. The Woodlands, Tx 77301**

By: **Rodney Sims / Lic # 10271, Teresa Sims / Lic # 20230**

09/16/2011 / 10:00am

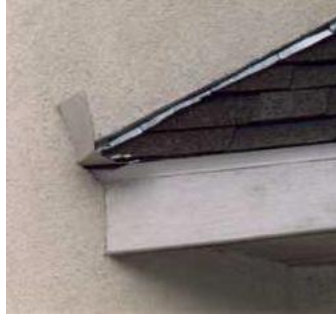
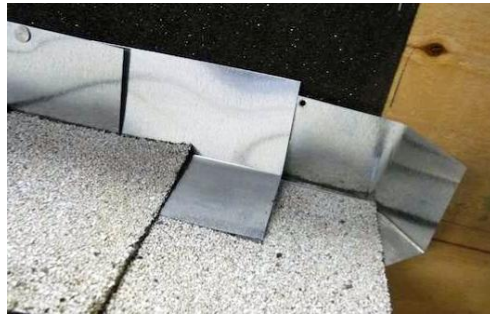
(See the following photos for proper installation of Kickout Flashings)

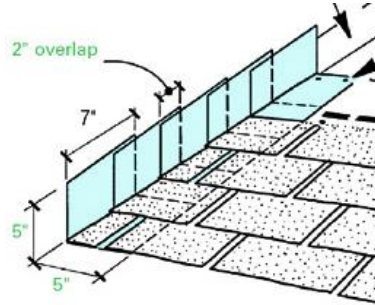
CODE REFERENCE: R905.2.8.4 (Sidewall Flashing.)

**-Flashing against a vertical sidewall shall be by the Step-Flashing method.
'Correct' Step-Flashing Installation (as per Building Code)**

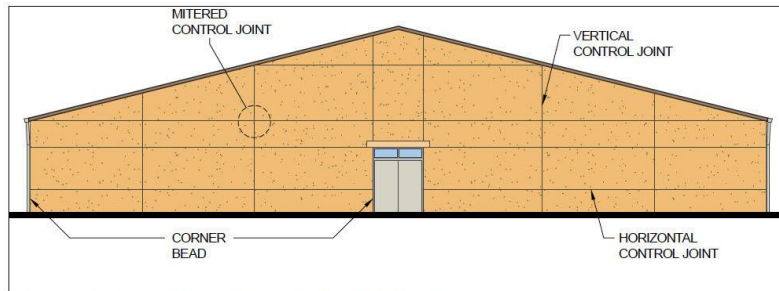
Drawing 4: Typical Arrangement of Control Joints

NOTE: Without control joints in the appropriate locations, slight ‘controlled’ movement is not possible and cracks in the stucco can occur.

(Sample of possible Control Joint spacing and configuration)

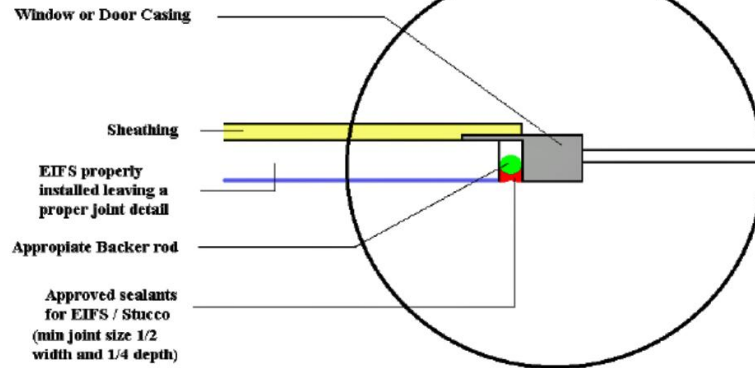
Proper Window and Door Detail

(SEE the below detail for an example of 'proper' Installation of a Stucco Casing Bead Joint around Windows and Doors.)

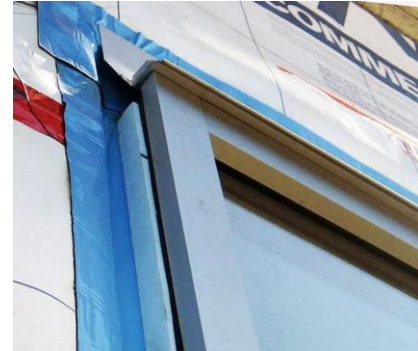
(Window with Proper Head Cap Flashing)

NOTE: The windows at the front of the garage are a different type, and have a 'pre-installed' Head Cap Flashing at the top. (If a 'pre-installed' Head Cap Flashing is NOT present on a window, one MUST be installed.)

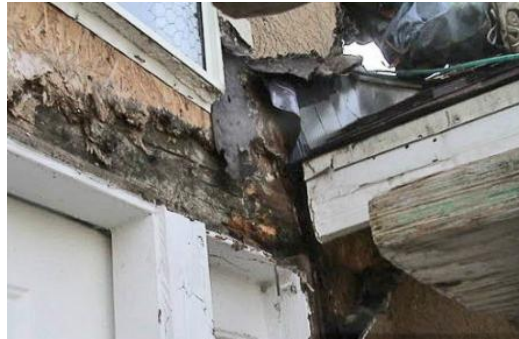
(SEE below 'SAMPLE' photo of damage from a incorrect Kickout and Fascia installation)
